Docket No. 217 – Development and Management Plan Inspection

Date: May 18, 2005

Location: 115 kV Underground Route – Gallows Hill Road Area

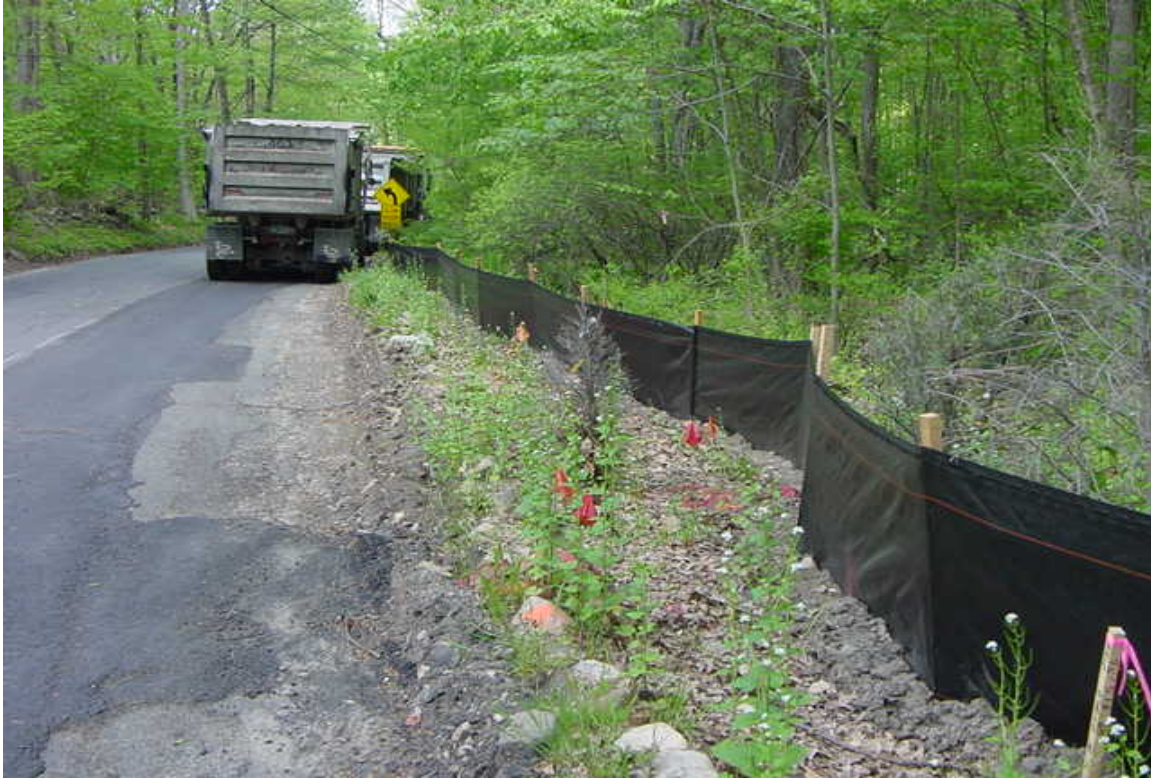
115 kV Gallows Hill Road- Silt fence protection along Gallows Hill Road. (5/18/05)

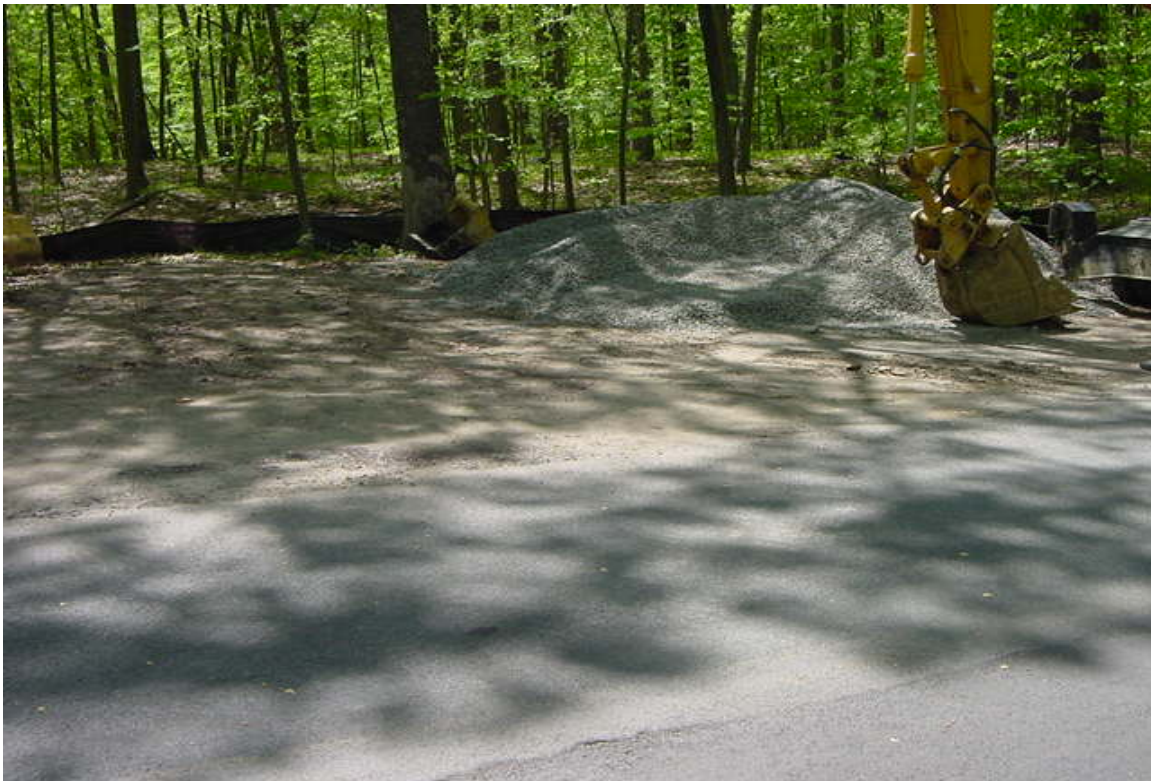
Staging area along Gallows Hill Road with gravel stockpile. (5/18/05)

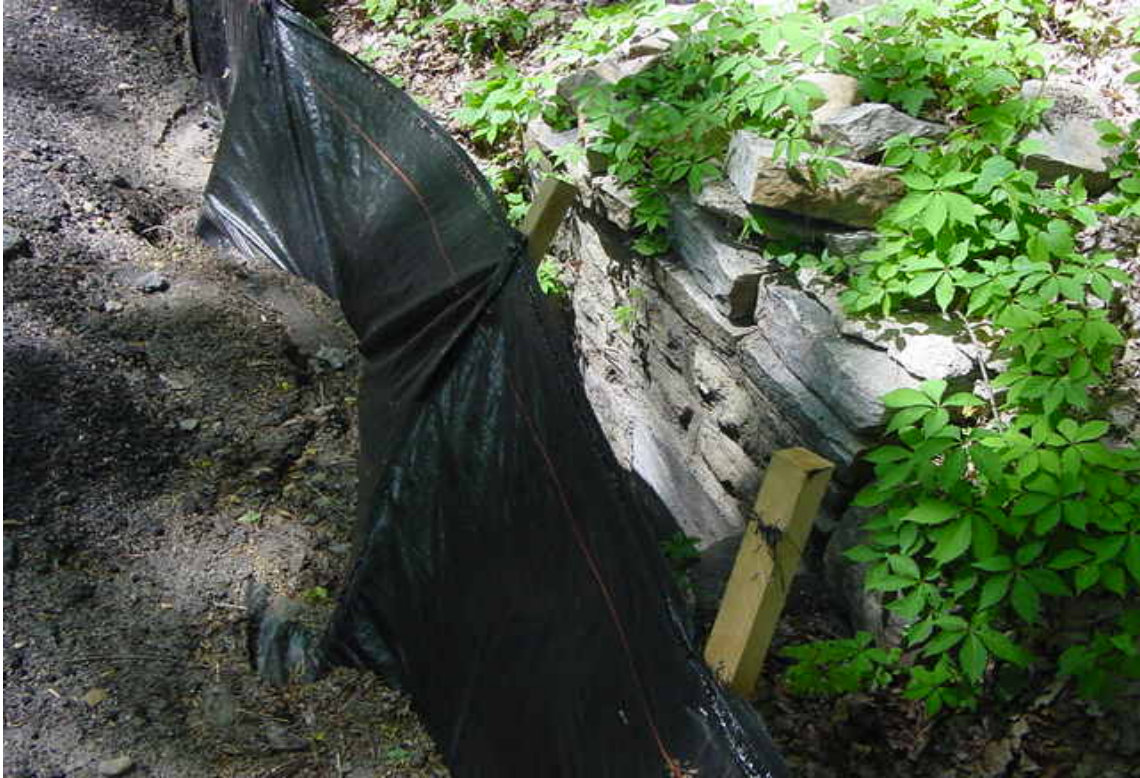
- One inlet was protected with silt fence but had some additional sediment piled against it. 5/18/05	- If the sediment is not being used to toe in the bottom of the silt fence, it should be pulled back. 5/18/05

Silt fence protection at inlet along Gallows Hill Road. (5/18/05)
